BLM Cedar City Field Office Site Inspection Report

January 8, 2002

To: Case file UTU-72232, 43 CFR 3809 POO
Gemstone Mining Inc., Red Emerald Mine

Subject: Site Inspection

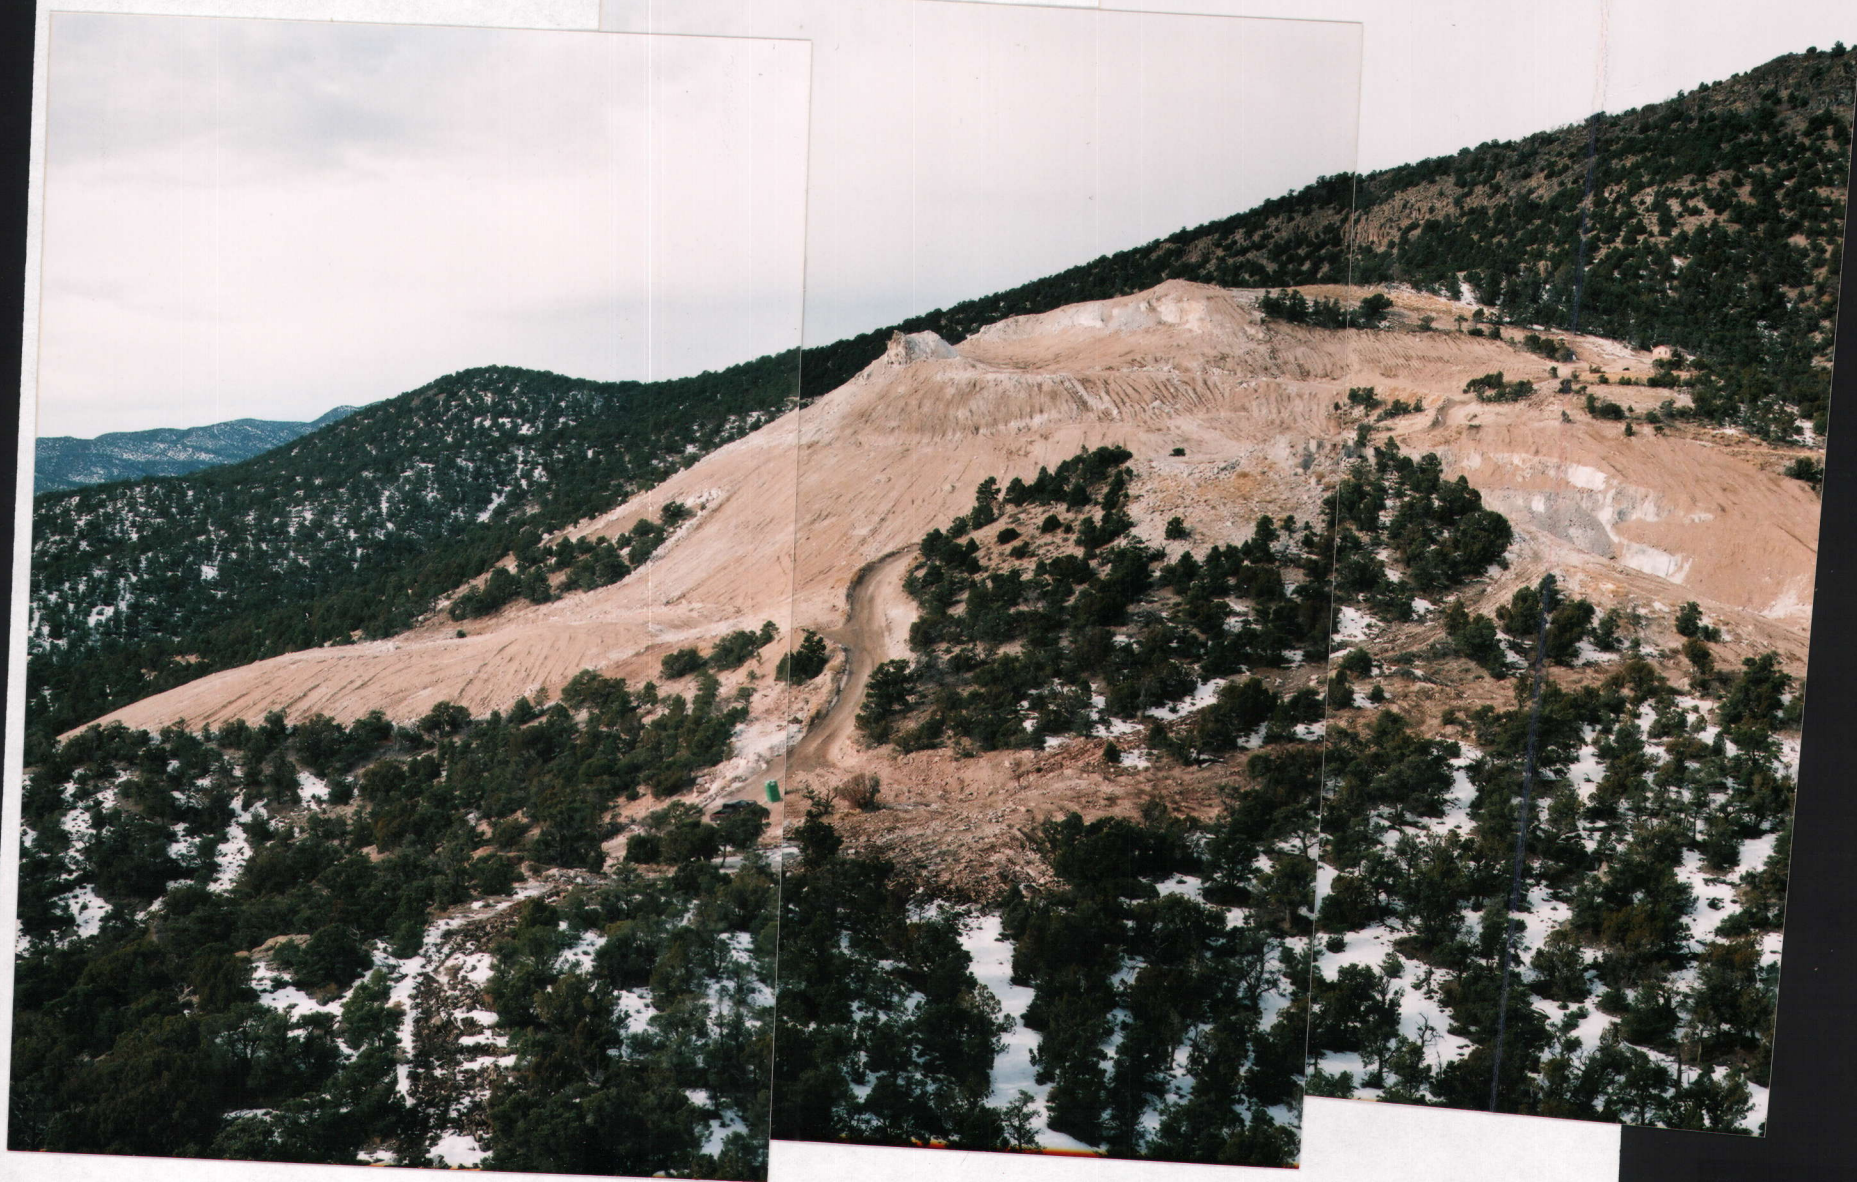
Photo 1: Panoramic view of reclaimed Red Emerald (GMI) mine site looking west from "squirrel rock" (hilltop elev. 6842' on topo). Note drastically reduced contrast of color by topsoiling the site. Photo taken January 8, 2002 by Ed Ginouves.

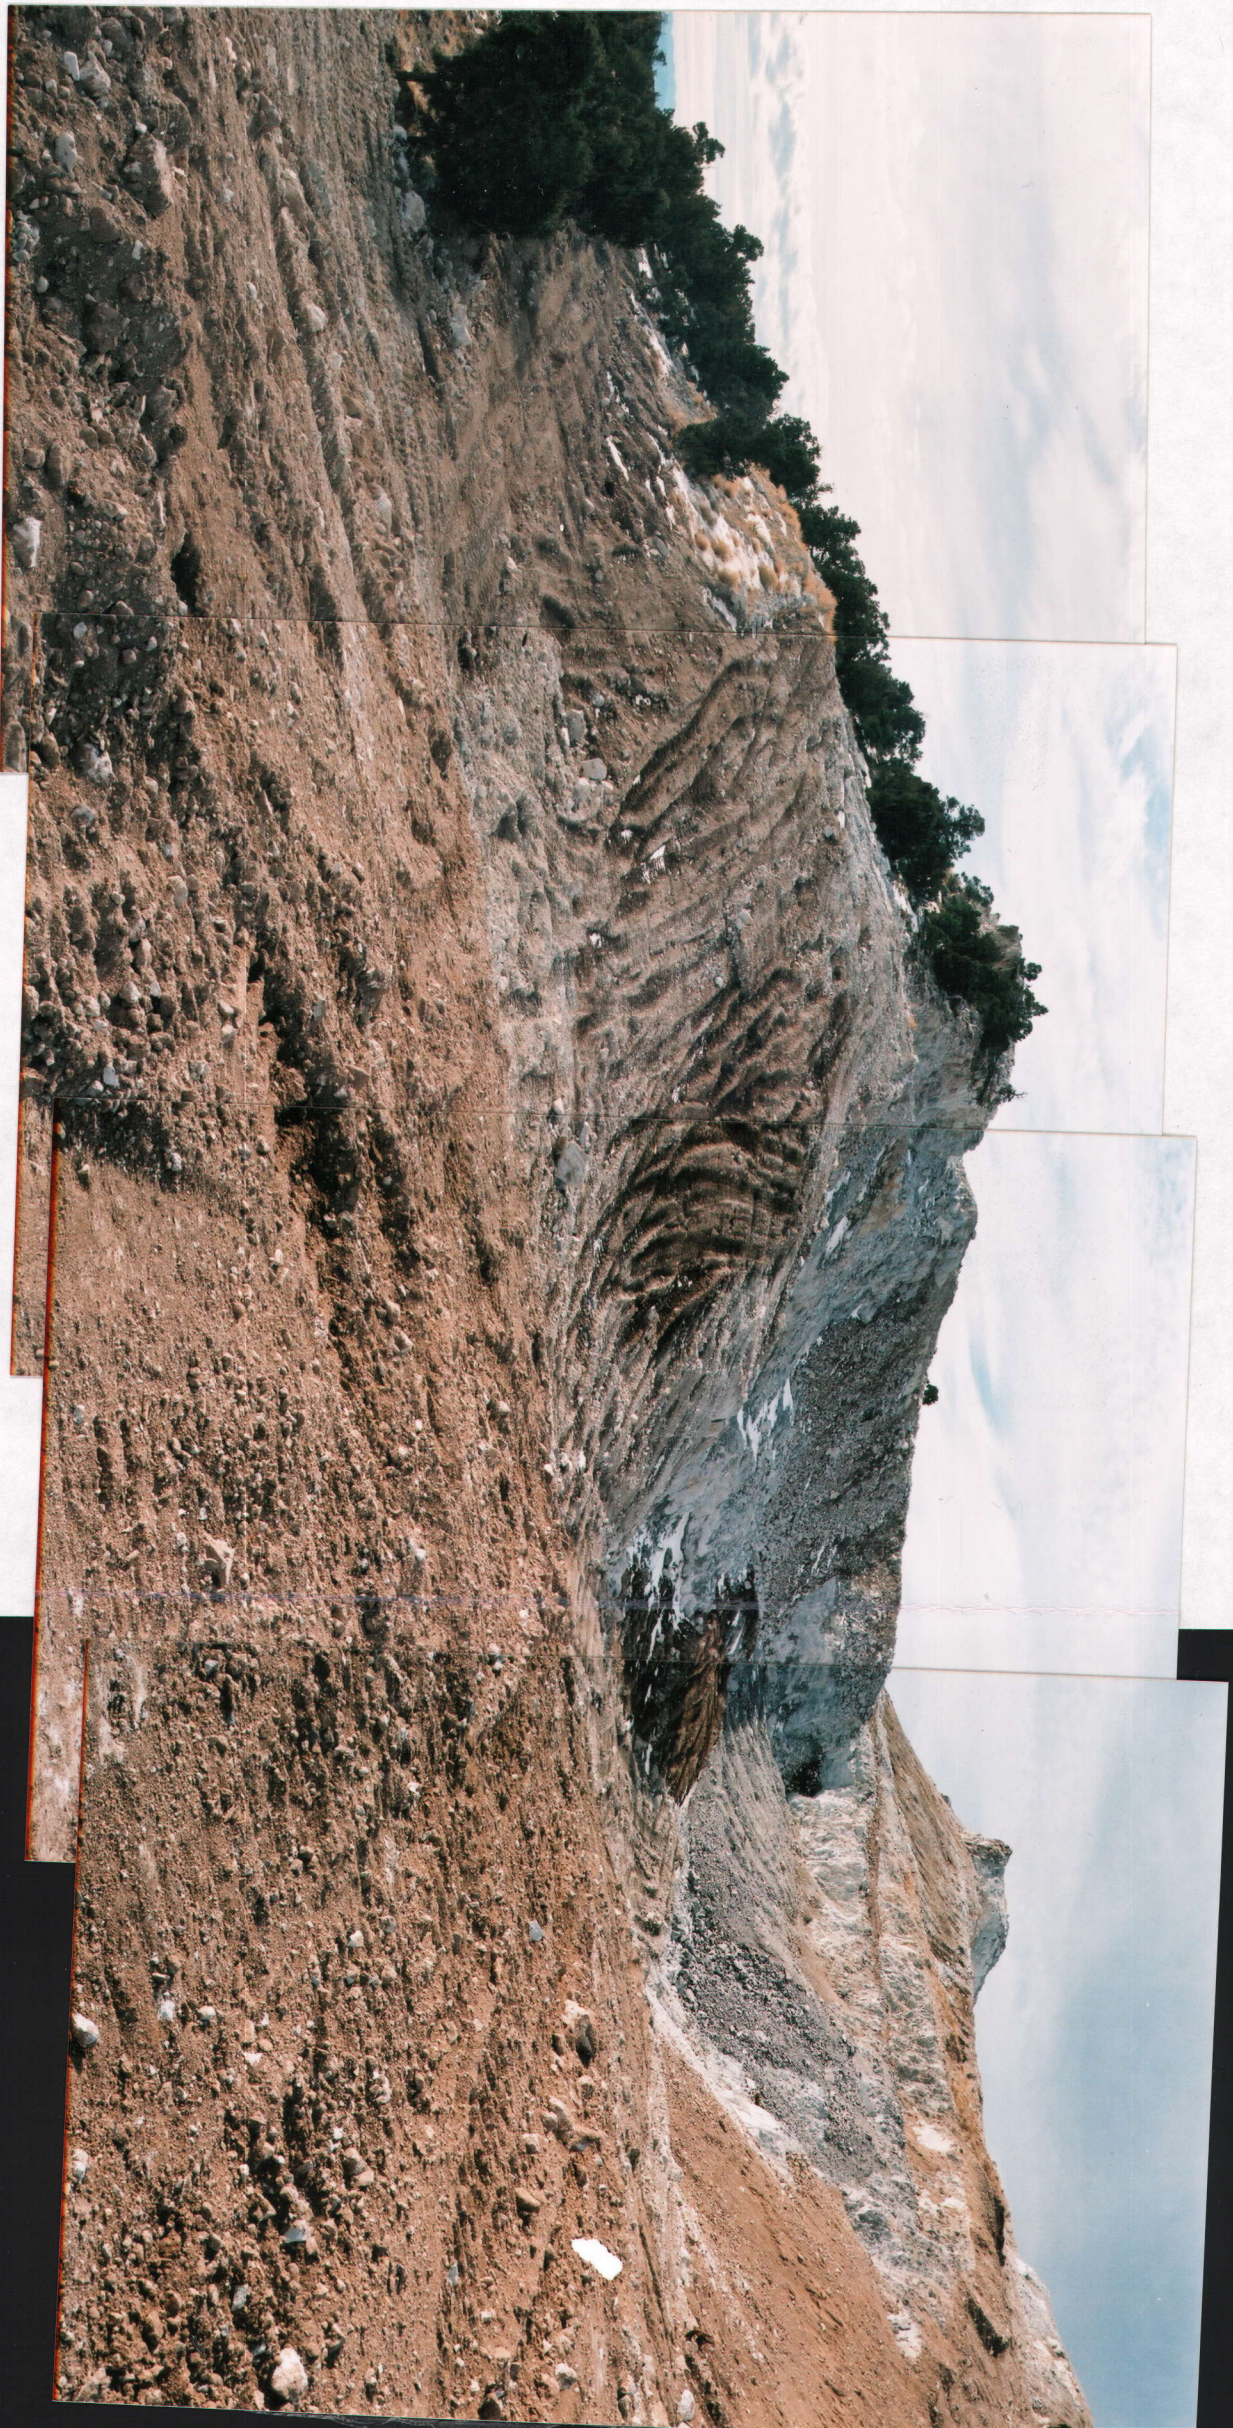
Photo 2: View of reclaimed lower (Harris) pit area looking southwest from edge of reclaimed lower pit waste dump. Photo taken January 8, 2002 by Ed Ginouves.

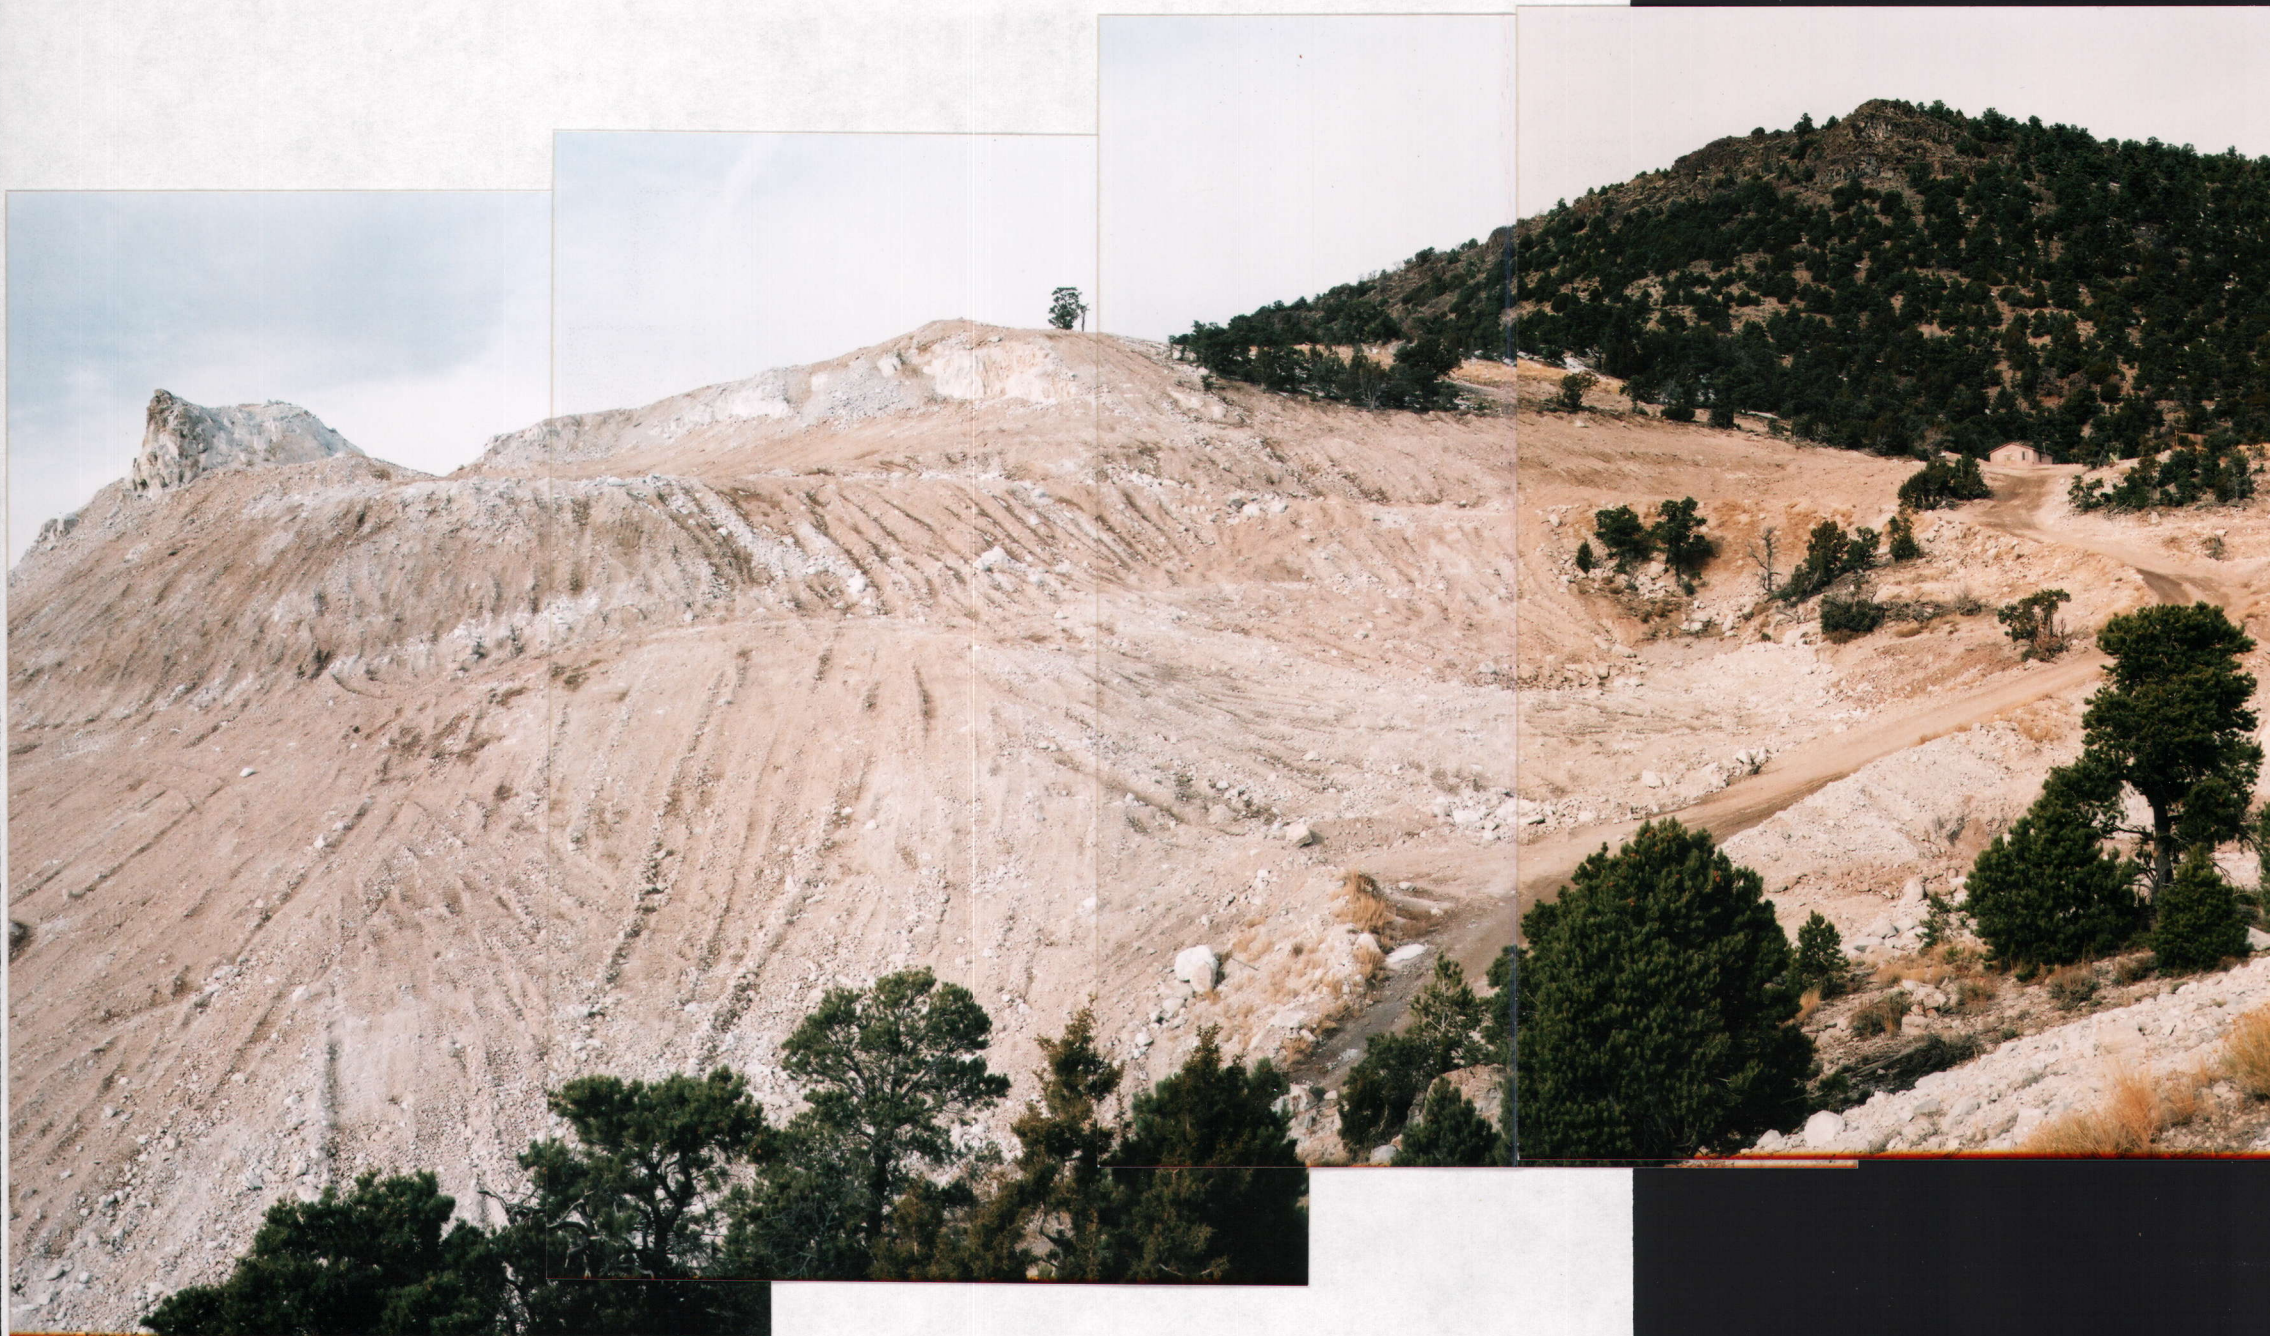
Photo 4: View of reclaimed upper pit and waste dump area, and upper portal area, looking southwest from remaining mine road. Photo taken January 8, 2002 by Ed Ginouves.

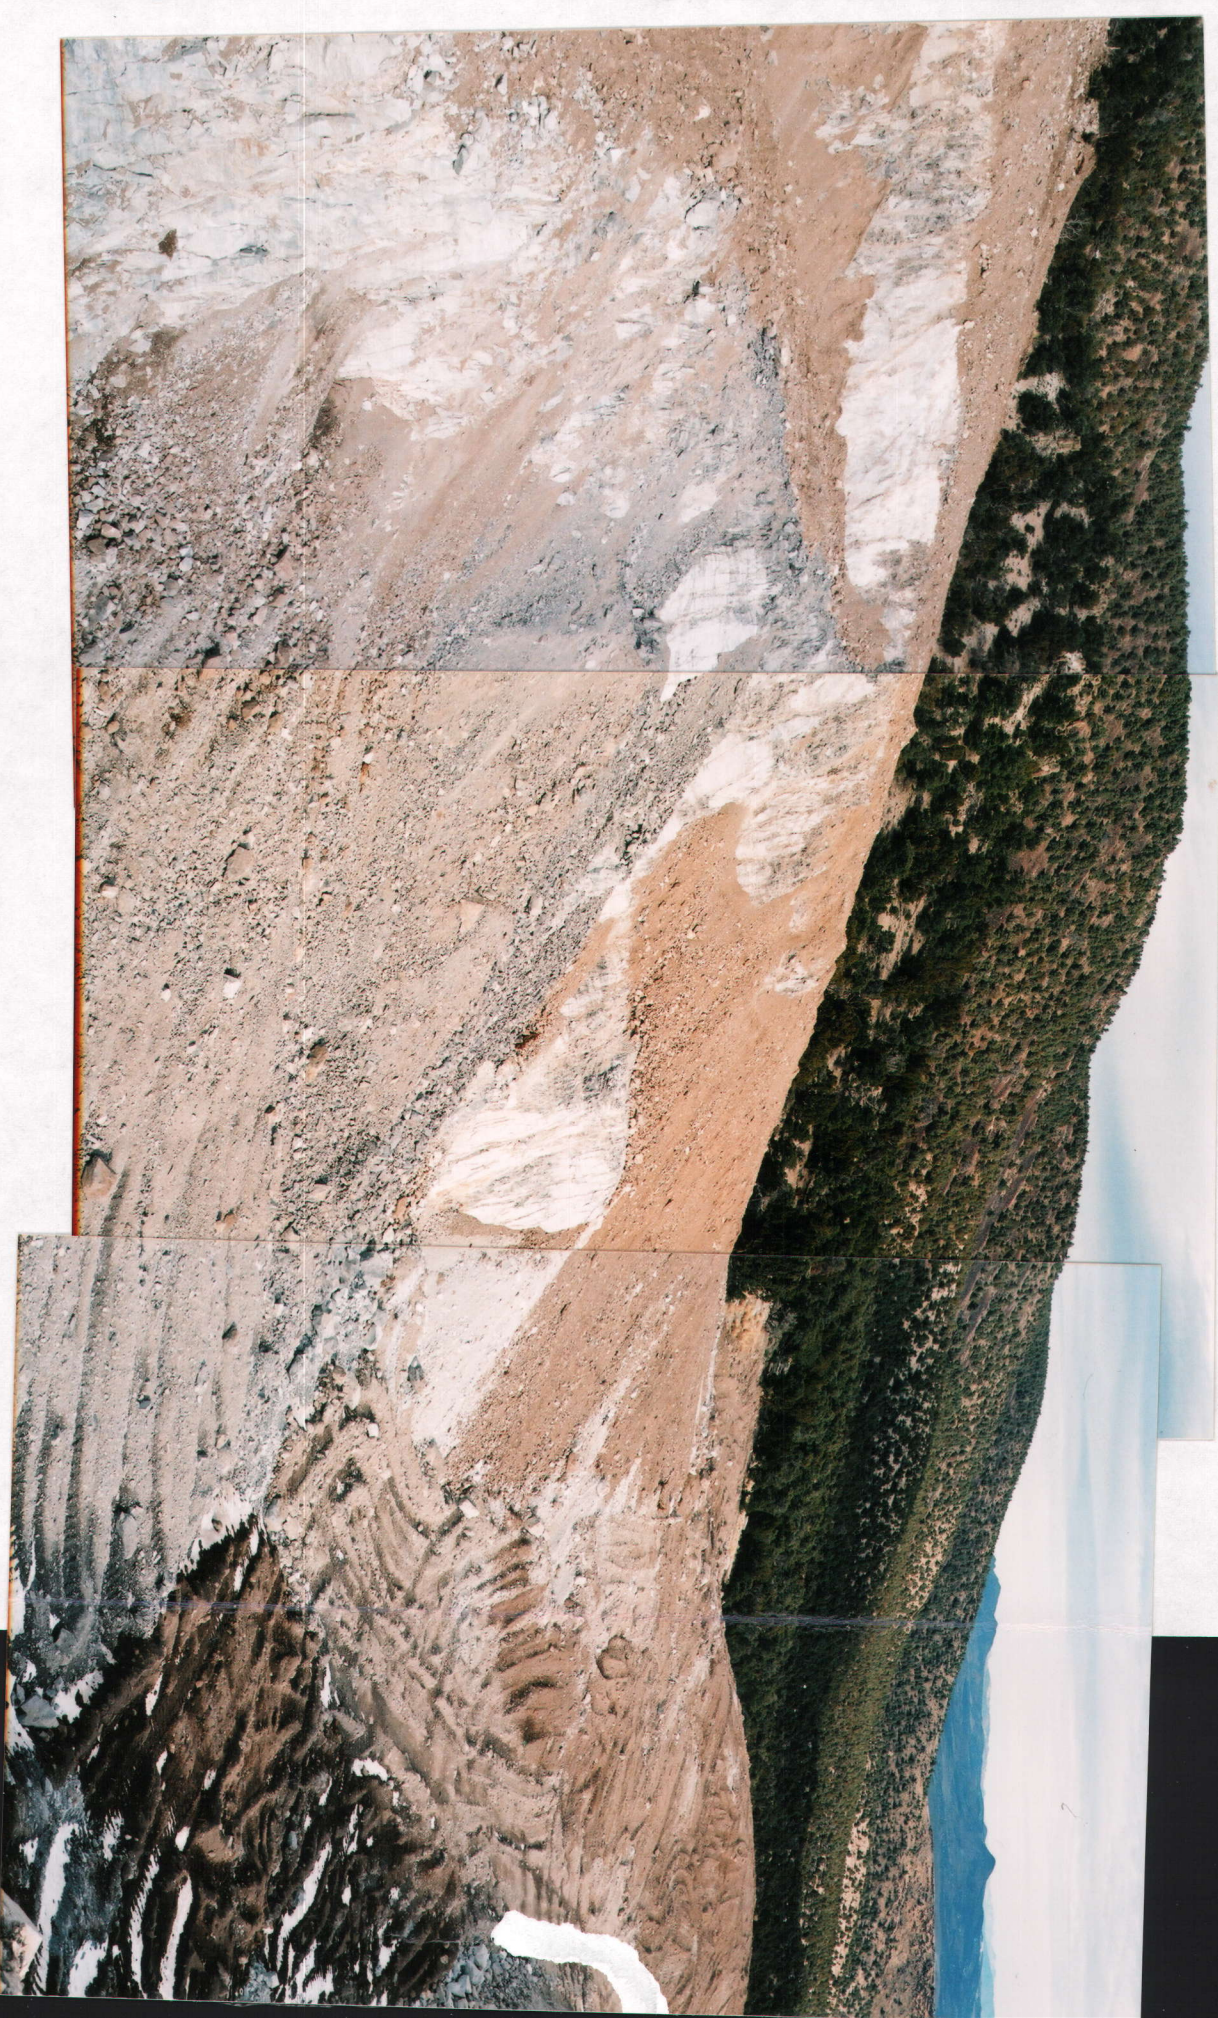
Photo 3: View of reclaimed lower (Harris) pit and waste dump area looking northeast from northwest edge of the pit area. Photo taken January 8, 2002 by Ed Ginouves.

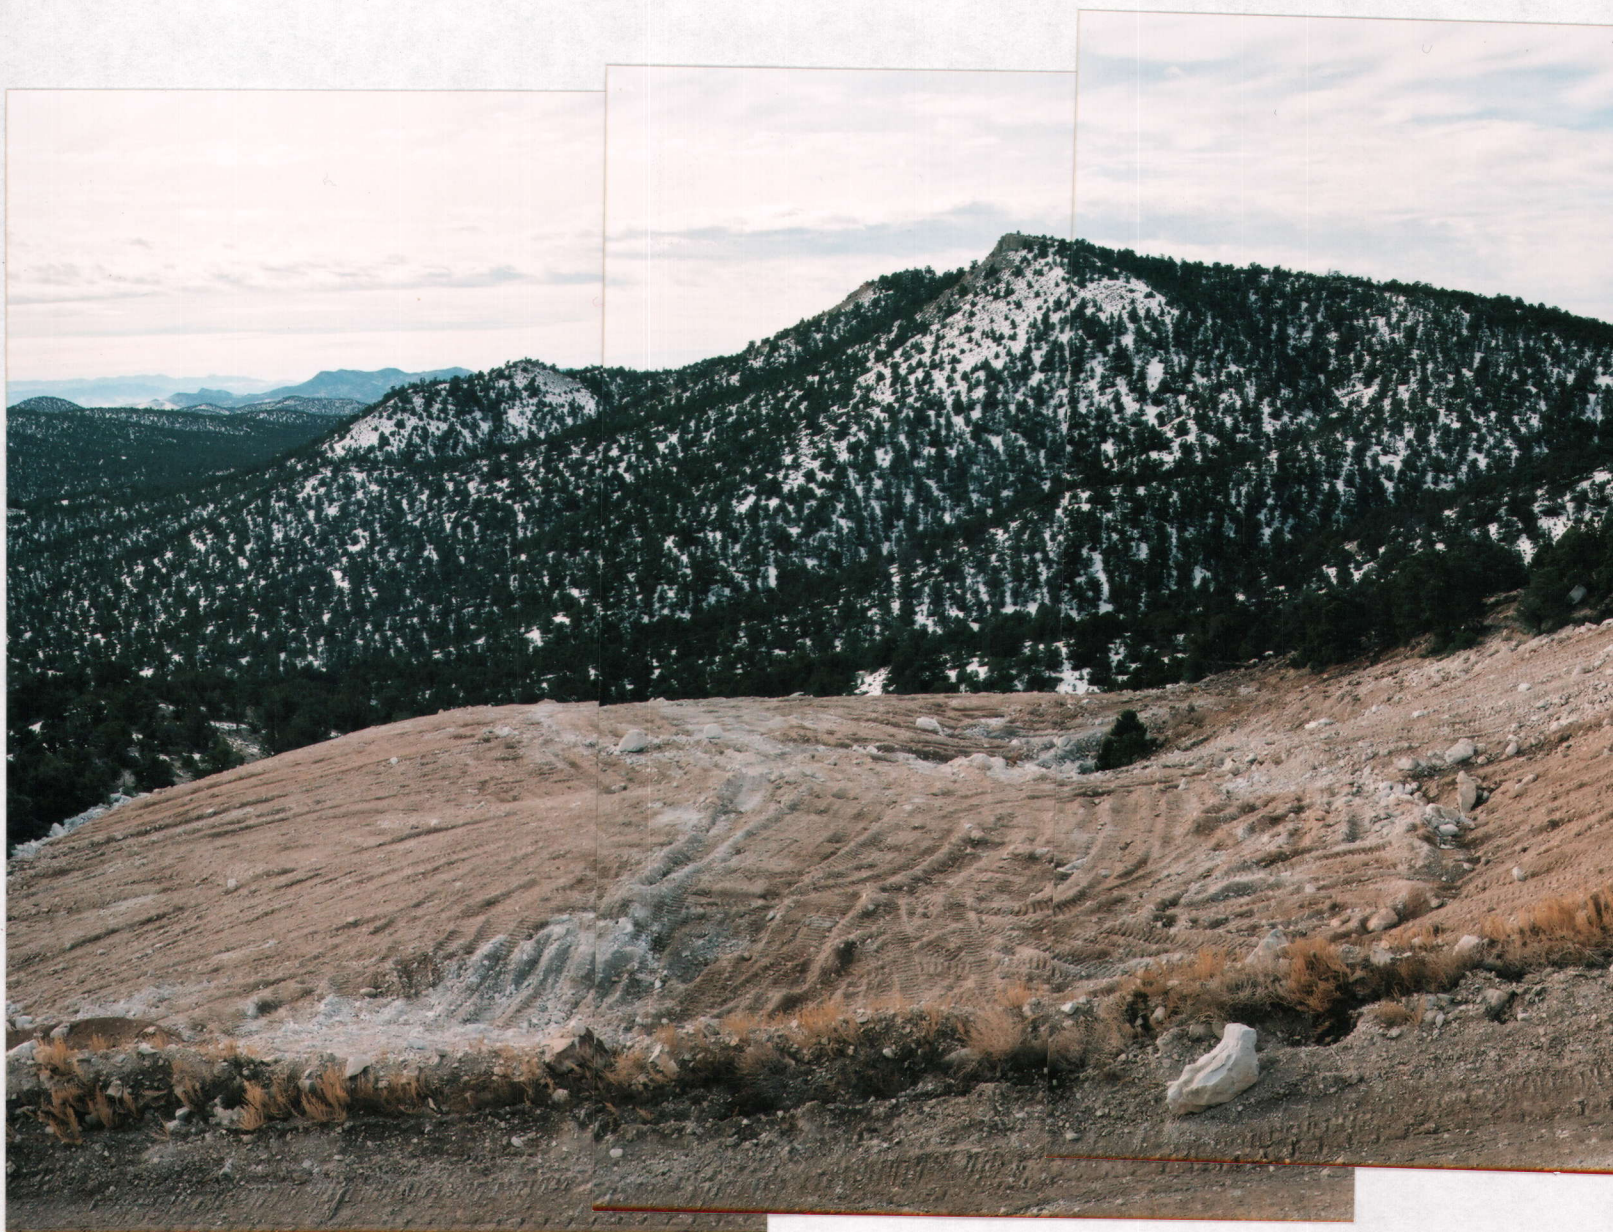
Photo 5: View of reclaimed GMI waste dump area, and lower portal bench area looking south from remaining mine road. Photo taken January 8, 2002 by Ed Ginouves.
